Manhole Inspection Summary

Manhole # S45E2_050MH

Location Address: **4100 Pennington Ave** Cross Street: **Plum-Olmstead**

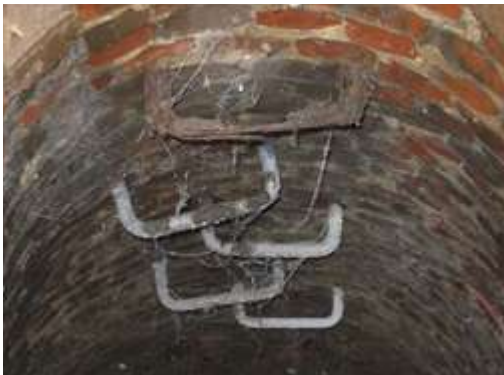
Steps Count: **5** Missing: **1** ☐ Corroded

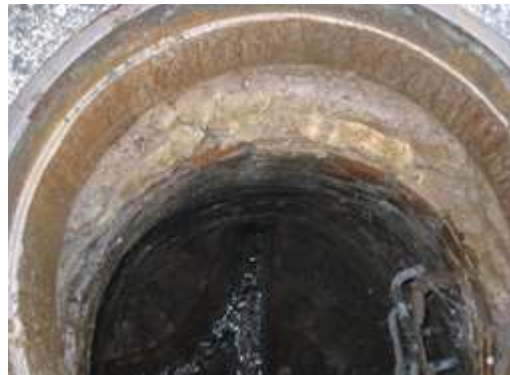
Defect 1

Frame Offset: **4.5** (in.) Condition: ☒ Sound ☐ Cracked ☐ Leaks

Frame offset

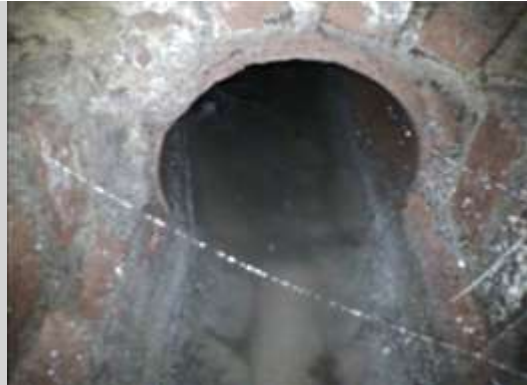
12 O'Clock Outflow

8 in. Circular Gravity Sewer
Pipe Out @ 12 O'Clock

Pipe Height: **9.6** (in.) Rod and Bar (Angled)
Pipe Material: **Clay** ☐ Pipe Lined
Invert Depth: **9.32** (ft.) Flow Characteristics: **Fast**
Deposits: ☒ None ☐ Mud ☐ Sludge ☐ Debris ☐ Grease
Silt Depth: (in.) Deposits Extent:
Infiltration: **None** Pipe Seal Cond: **Sound**

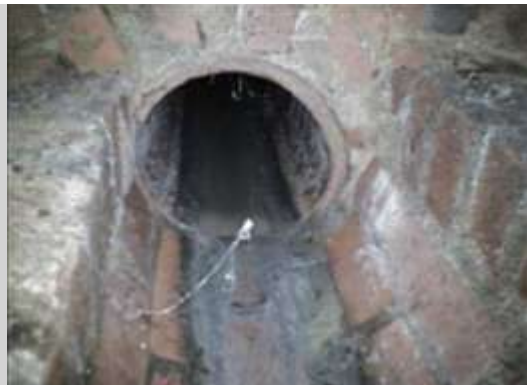
6 O'Clock Inflow

8 in. Circular Gravity Sewer
Pipe In @ 6 O'Clock

Pipe Height: **10.8** (in.) Rod and Bar (Angled)
Pipe Material: **Clay** ☐ Pipe Lined
Invert Depth: **9.21** (ft.) Flow Characteristics: **Fast**
Deposits: ☒ None ☐ Mud ☐ Sludge ☐ Debris ☐ Grease
Silt Depth: (in.) Deposits Extent:
Infiltration: **None** Pipe Seal Cond: **Sound**

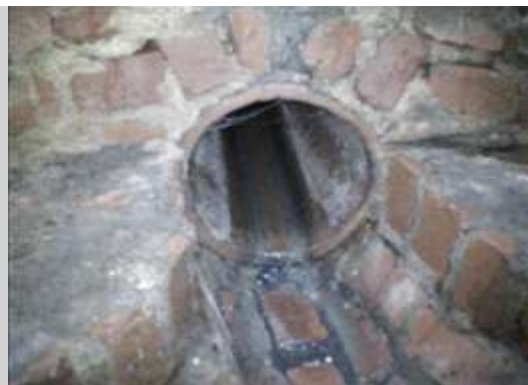
9 O'Clock Inflow

8 in. Circular Gravity Sewer

Pipe In @ 9 O'Clock

Pipe Height: **8.4** (in.) Rod and Bar (Angled)

Invert Depth: **8.81** (ft.) Flow Characteristics: **Fast**

Infiltration: **None** Pipe Seal Cond: **Sound**
